## Scope

An aftermarket replacement Valve Cover for OE part number 11 12 7 552 281, sold by company noted as OTHER, was reviewed using the tools, measurement equipment and quality verification processes in use at APA Industries. This report itemizes non-conformances found with the OTHER Valve Cover when compared to cover 11 12 7 552 281 from the original equipment manufacturer (OEM).

The OTHER brand Valve Cover 11 12 7 552 281 does not pass APA Quality Inspection.

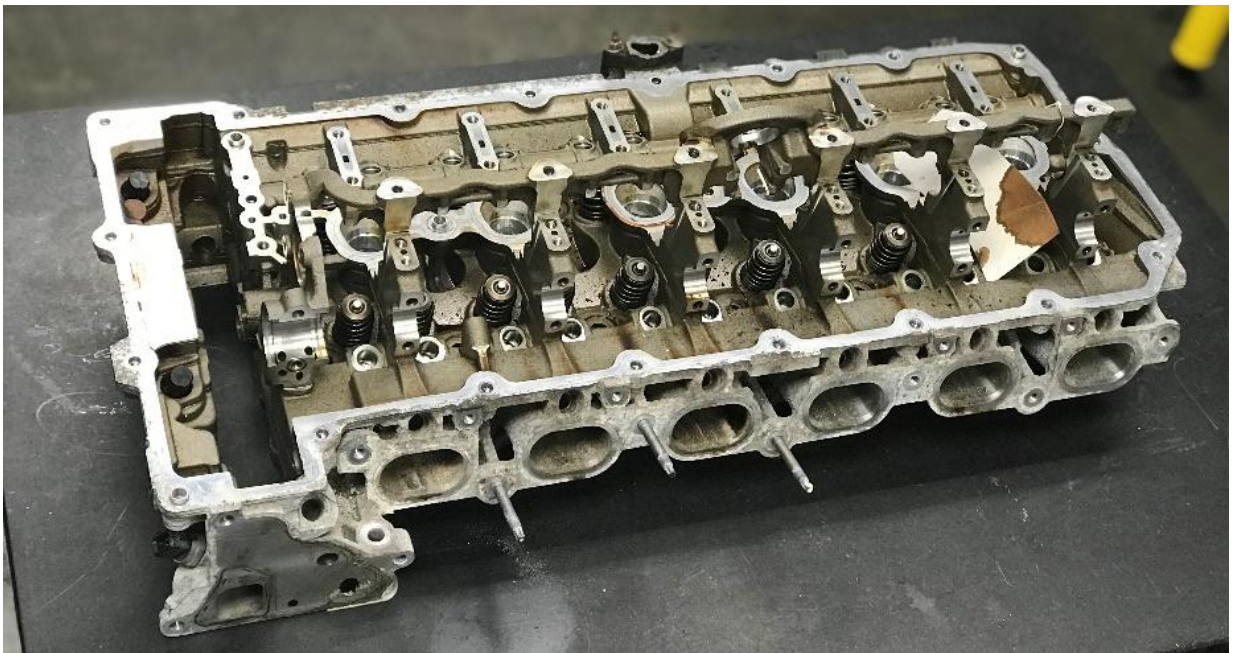
Figure 1: OE Engine Head

The OTHER valve cover was attempted to be installed on the OE Engine Head Shown in Figure 1. Installation was attempted by 4 other members of the engineering staff with the same result. The OTHER Valve cover does not fit the OE Engine Head properly. The installation attempts revealed 2 bolts that could not achieve proper fit and torque, shown in Figure 2 and Figure 3.

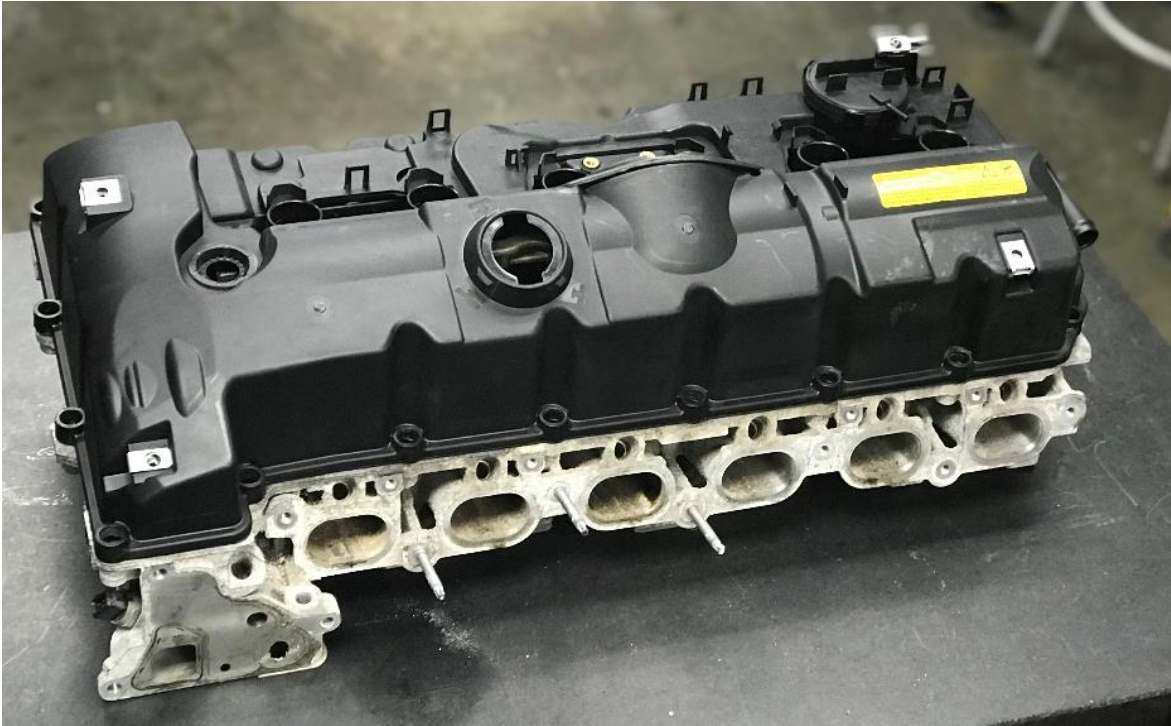
Figure 1a: OTHER valve cover seated on OE Engine Head without fasteners

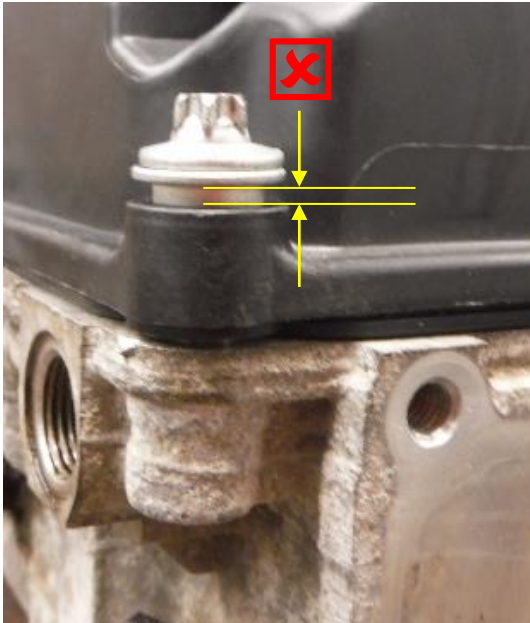
Figure 2a: Electric impact tool achieved specified torque, yet gasket was not compressed due to sleeve stand off.

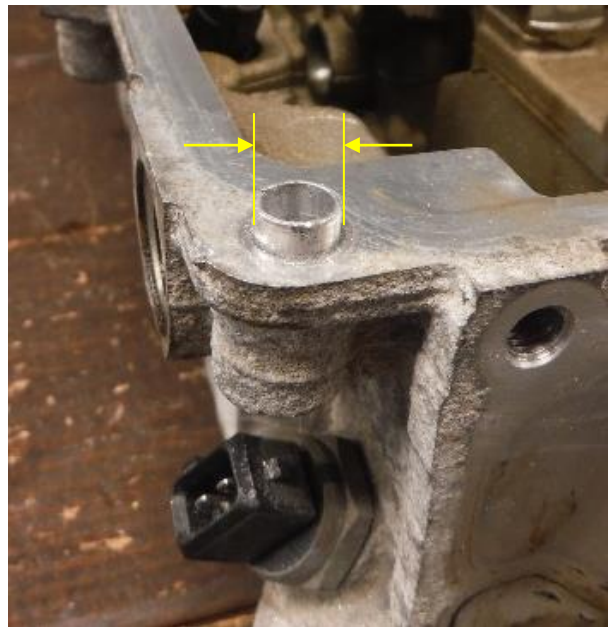
Figure 2b: Locating feature on engine head has larger OD than fastener sleeve ID.

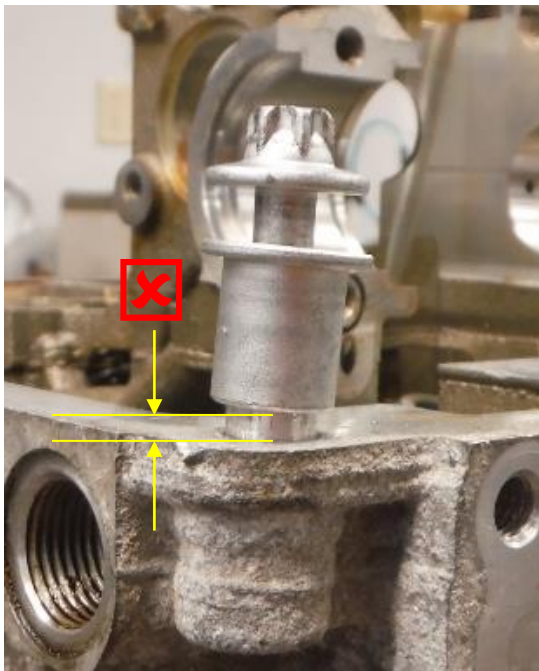
Figure 2c: Female fastener sleeve could not accommodate male locating feature.

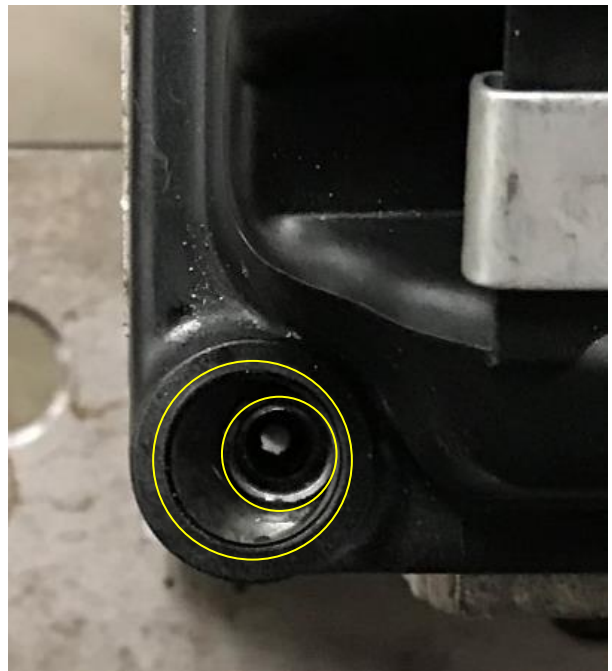
Figure 2d: Valve cover without bolt or sleeve. Housing must be forcibly deformed by installer to align fastener holes.

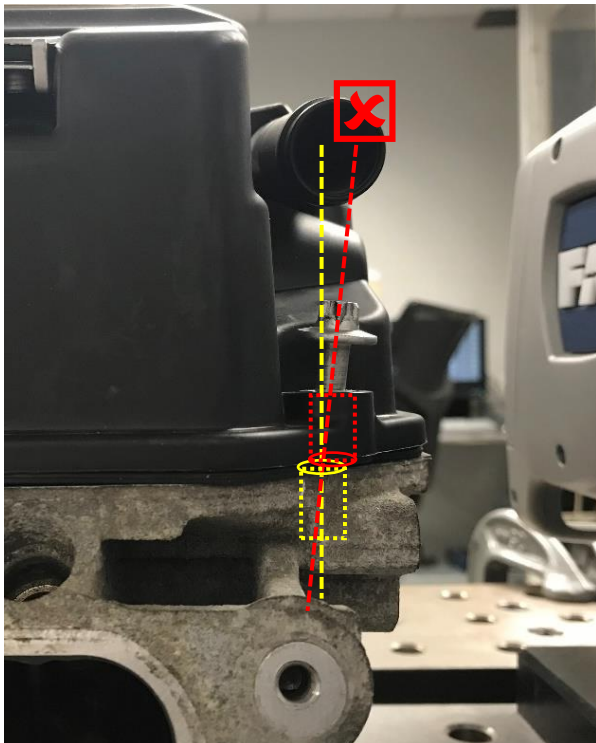
Figure 3a: NG Part Fit Detail: bolt did not achieve specified torque due to part dimensions.

Valve Cover hole location creates a NG bolt angle (in red), which did not allow the fastener to be installed to proper torque.

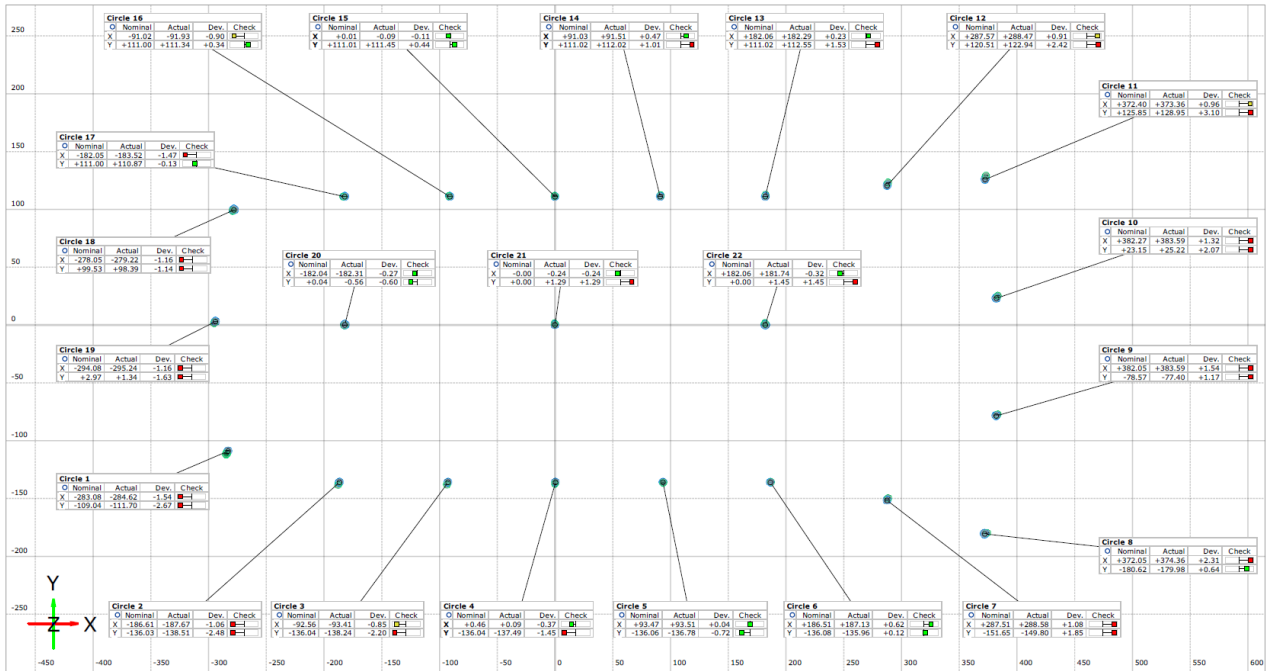
Figure 4: CMM DATA: FARO ARM

Applying a positional tolerance on each point of  $\pm 1.0\text{mm}$ , the OTHER valve cover has 17 out of 22 holes with a NG hole position in either the x-direction, y-direction, or both.

Additionally, the holes on the left side of the image, holes 18, 19 and 1, are off location in the X negative direction. The holes on the right side of the image, holes 11, 10, 9 and 8, are off position in the X positive direction. This is an additive situation. If you install a bolt into one end of the valve cover, all of the error is pushed to the other end of the part, causing the NG install experienced during the part fit activity.

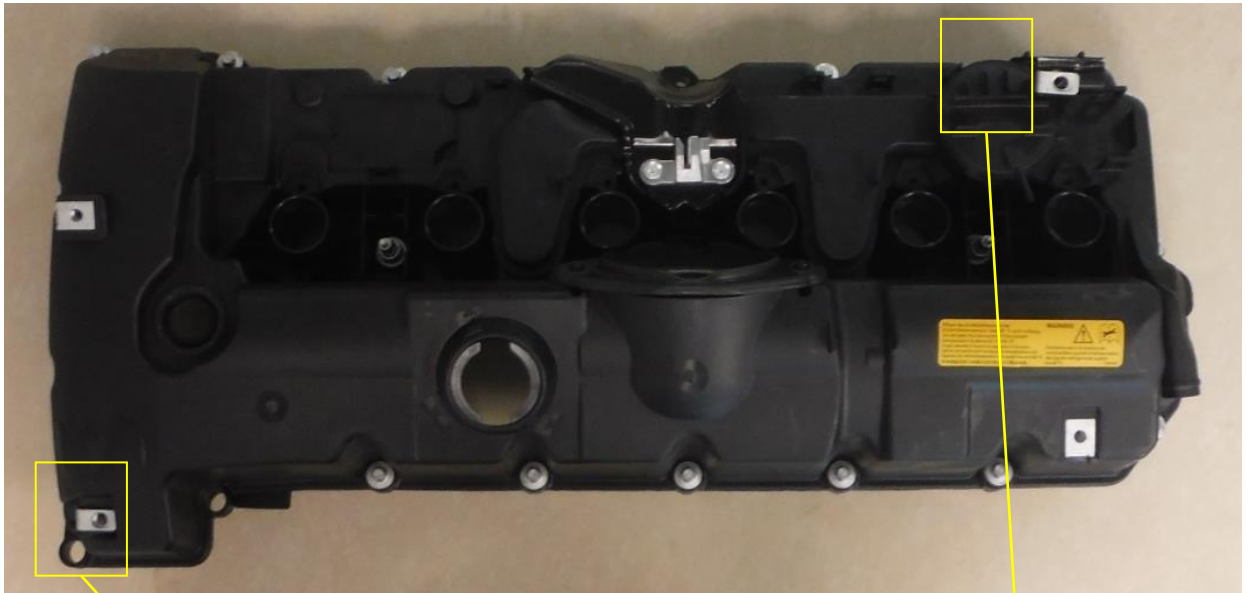
Figure 5: Fasteners Falling Out

Upon unboxing, the fasteners shown in Figure 5 fell out of the valve cover assembly with little or no outside influence. This is not acceptable for customers. The cover molding must have a proper press-fit/interference fit between the valve cover main body and the fasteners.

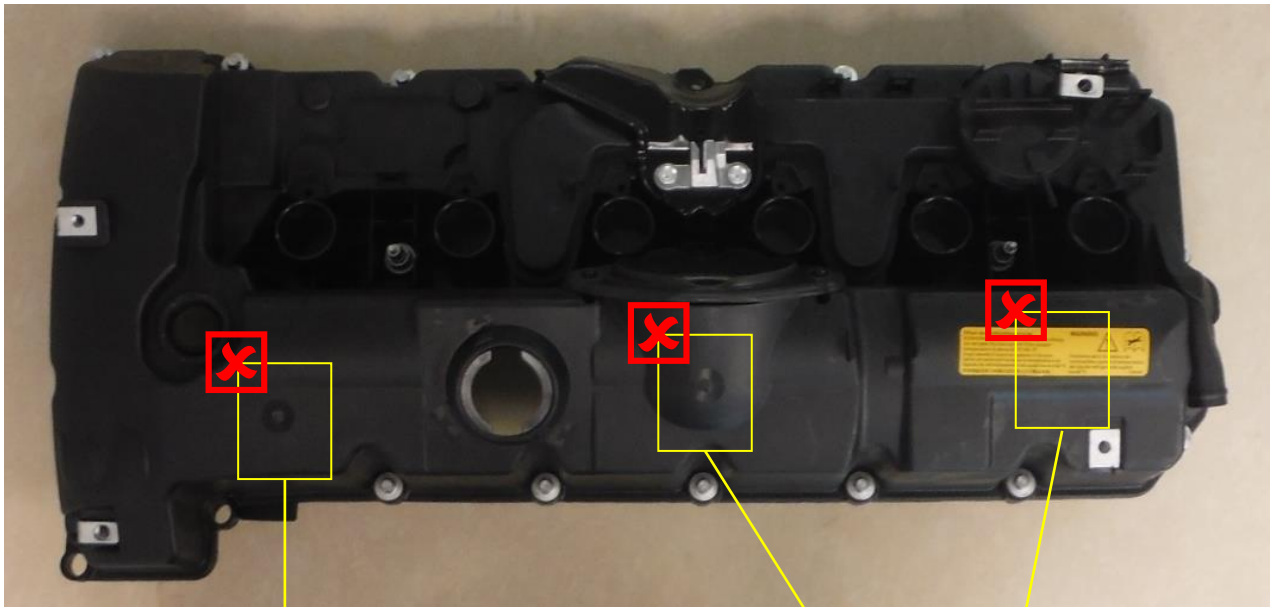
Figure 6: NG Appearance - Tooling Marks

The main molding of the valve cover has rough tooling marks from the injection molding process. These marks are located on the top of the part, where they are visible in the engine bay of the automobile. This is an NG appearance for the customer.

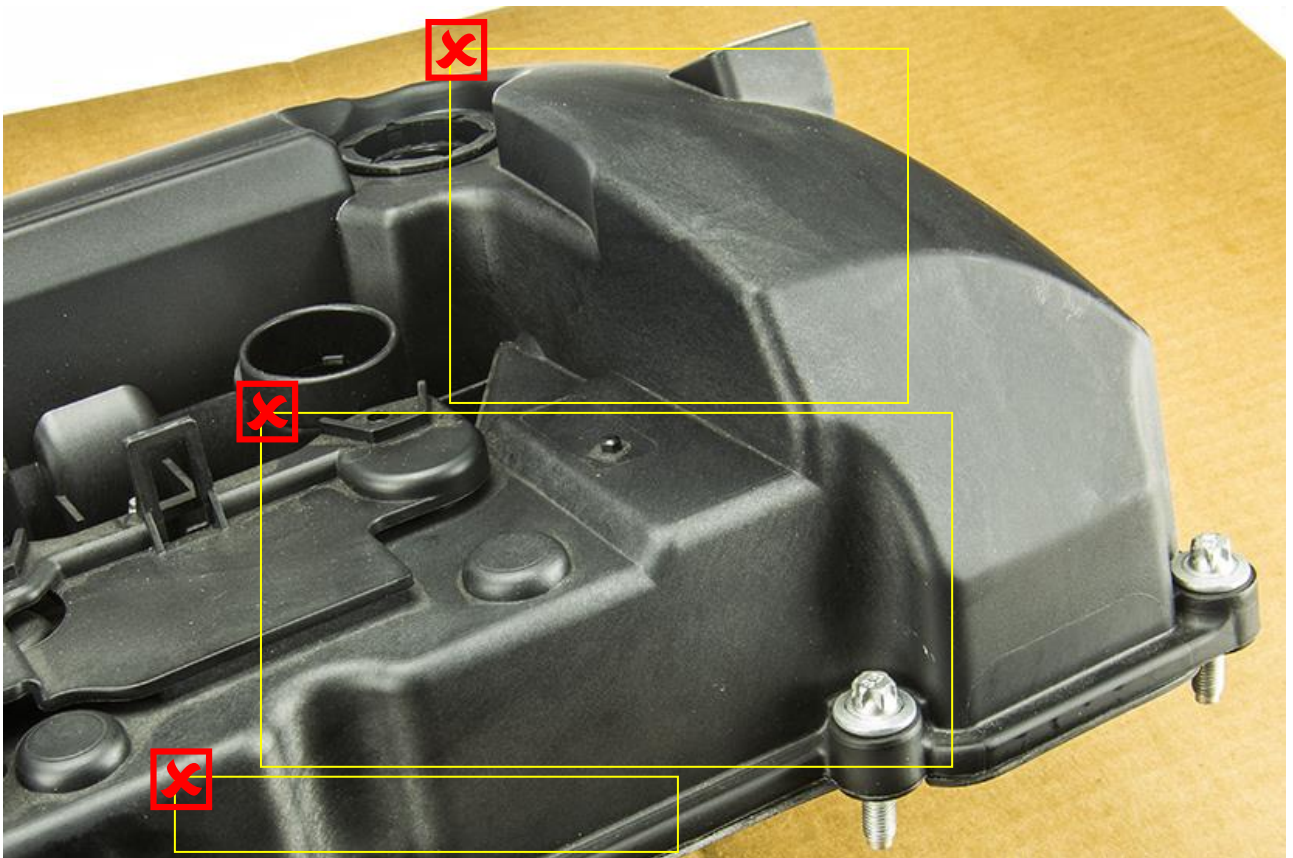
Figure 7: NG Appearance – Surface Finish

The surface of the OTHER Valve Cover has a mottled, matte grey appearance in areas, which suggests a high percentage of regrind (recycled) plastic. The OEM Valve Cover is an even black color, which is consistent with the use of virgin plastic. (A recycled plastic can never achieve the full mechanical properties of its virgin form.)
