Quality Analysis Report

Competitor's Valve Cover 11 12 7 552 281

Author: Matt Barnhouse, BSME Date: 8/27/2018

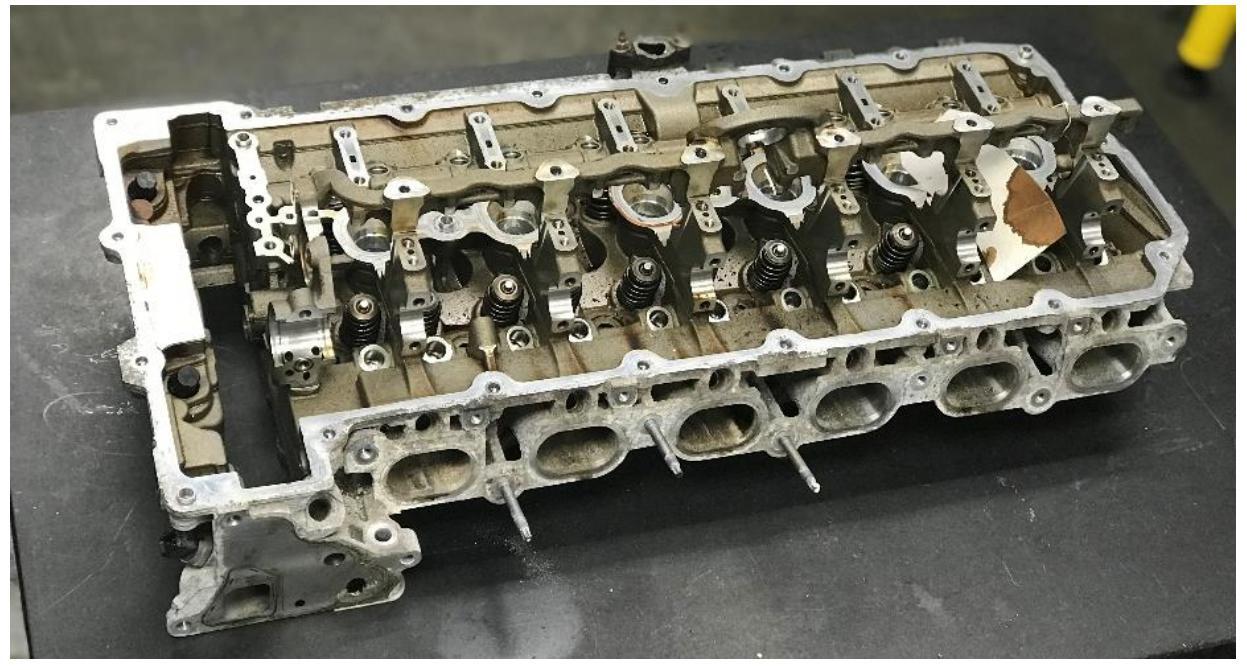
Figure 1: OE Engine Head

The OTHER valve cover was attempted to be installed on the OE Engine Head Shown in Figure 1. Installation was attempted by 4 other members of the engineering staff with the same result. The OTHER Valve cover does not fit the OE Engine Head properly. The installation attempts revealed 2 bolts that could not achieve proper fit and torque, shown in Figure 2 and Figure 3.

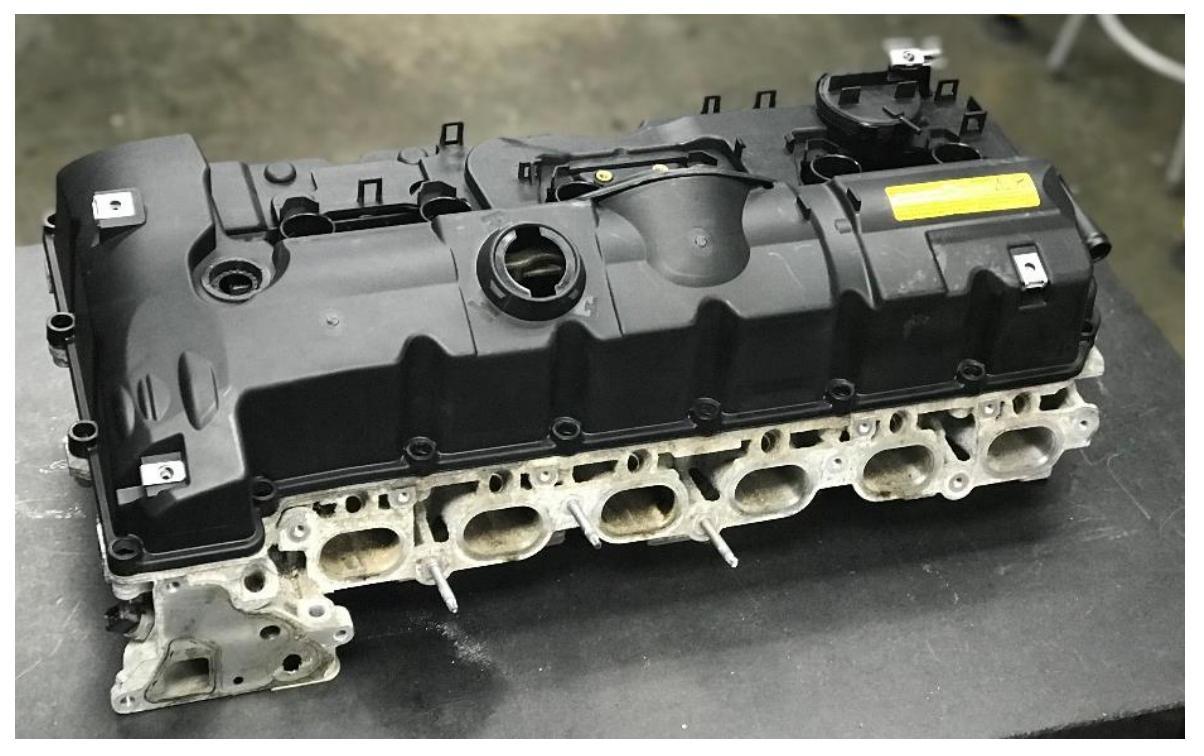
Figure 1a: OTHER valve cover seated on OE Engine Head without fasteners

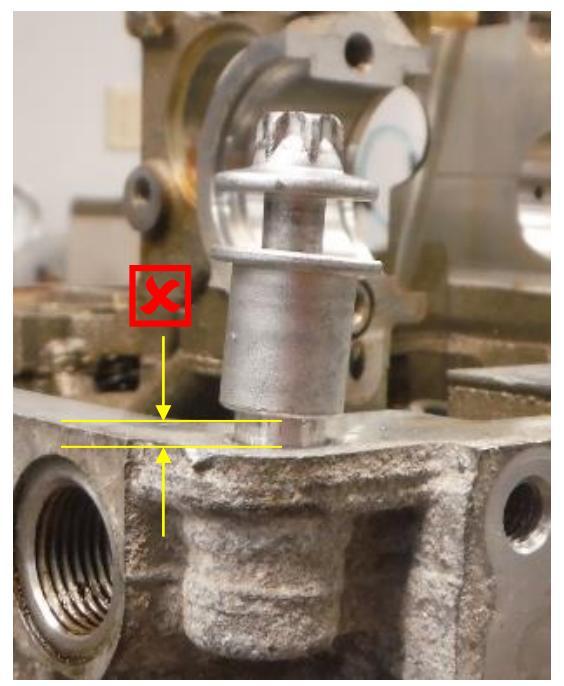
Figure 2a: Electric impact tool achieved specified torque, yet gasket was not compressed due to sleeve stand off.

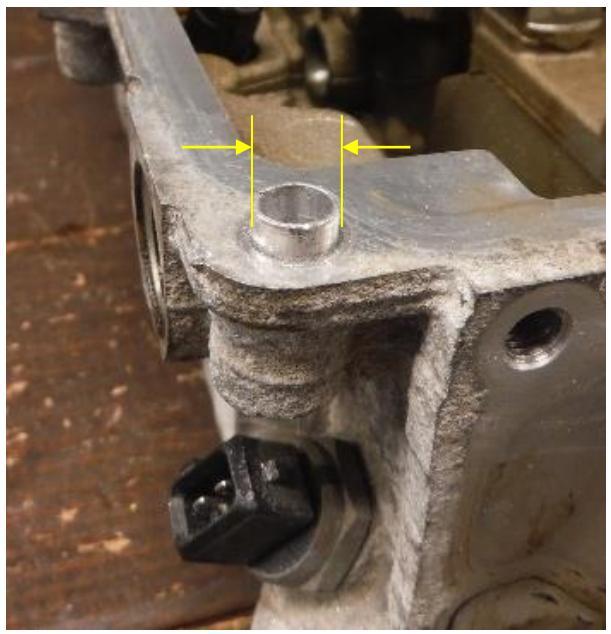
Figure 2c: Female fastener sleeve could not accommodate male locating feature.

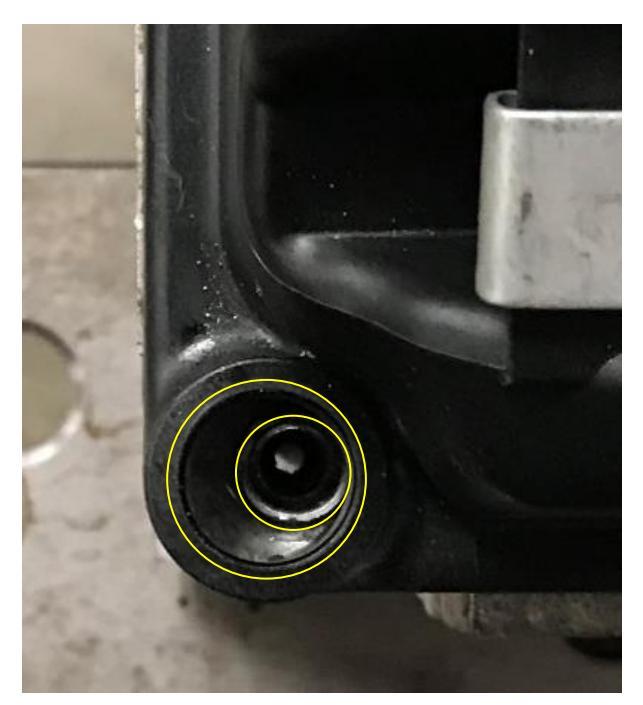
Figure 2b: Locating feature on engine head has larger OD than fastener sleeve ID.

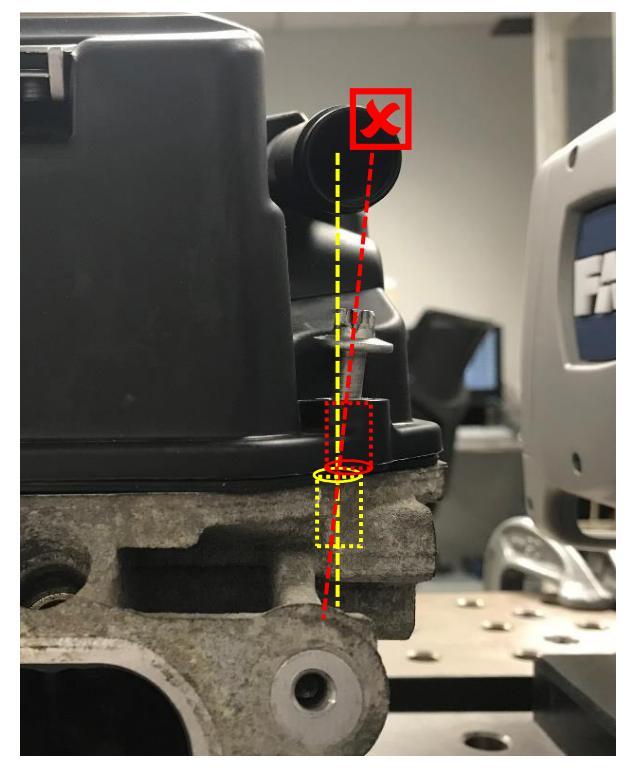
Figure 3a: NG Part Fit Detail: bolt did not achieve specified torque due to part dimensions.

Valve Cover hole location creates a NG bolt angle (in red), which did not allow the fastener to be installed to proper torque.

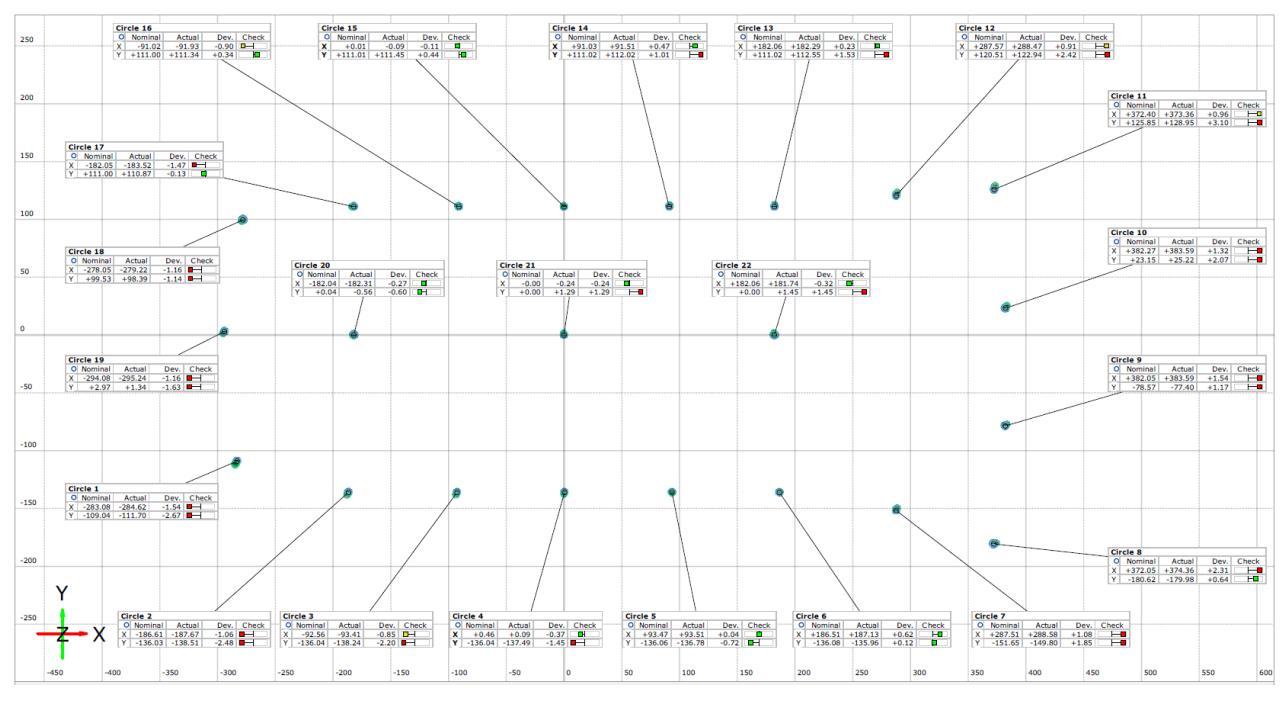
Figure 4: CMM DATA: FARO ARM

Applying a positional tolerance on each point of \pm 1.0mm, the OTHER valve cover has 17 out of 22 holes with a NG hole position in either the x-direction, y-direction, or both.

Additionally, the holes on the left side of the image, holes 18, 19 and 1, are off location in the X negative direction. The holes on the right side of the image, holes 11, 10, 9 and 8, are off position in the X positive direction. This is an additive situation. If you install a bolt into one end of the valve cover, all of the error is pushed to the other end of the part, causing the NG install experienced during the part fit activity.

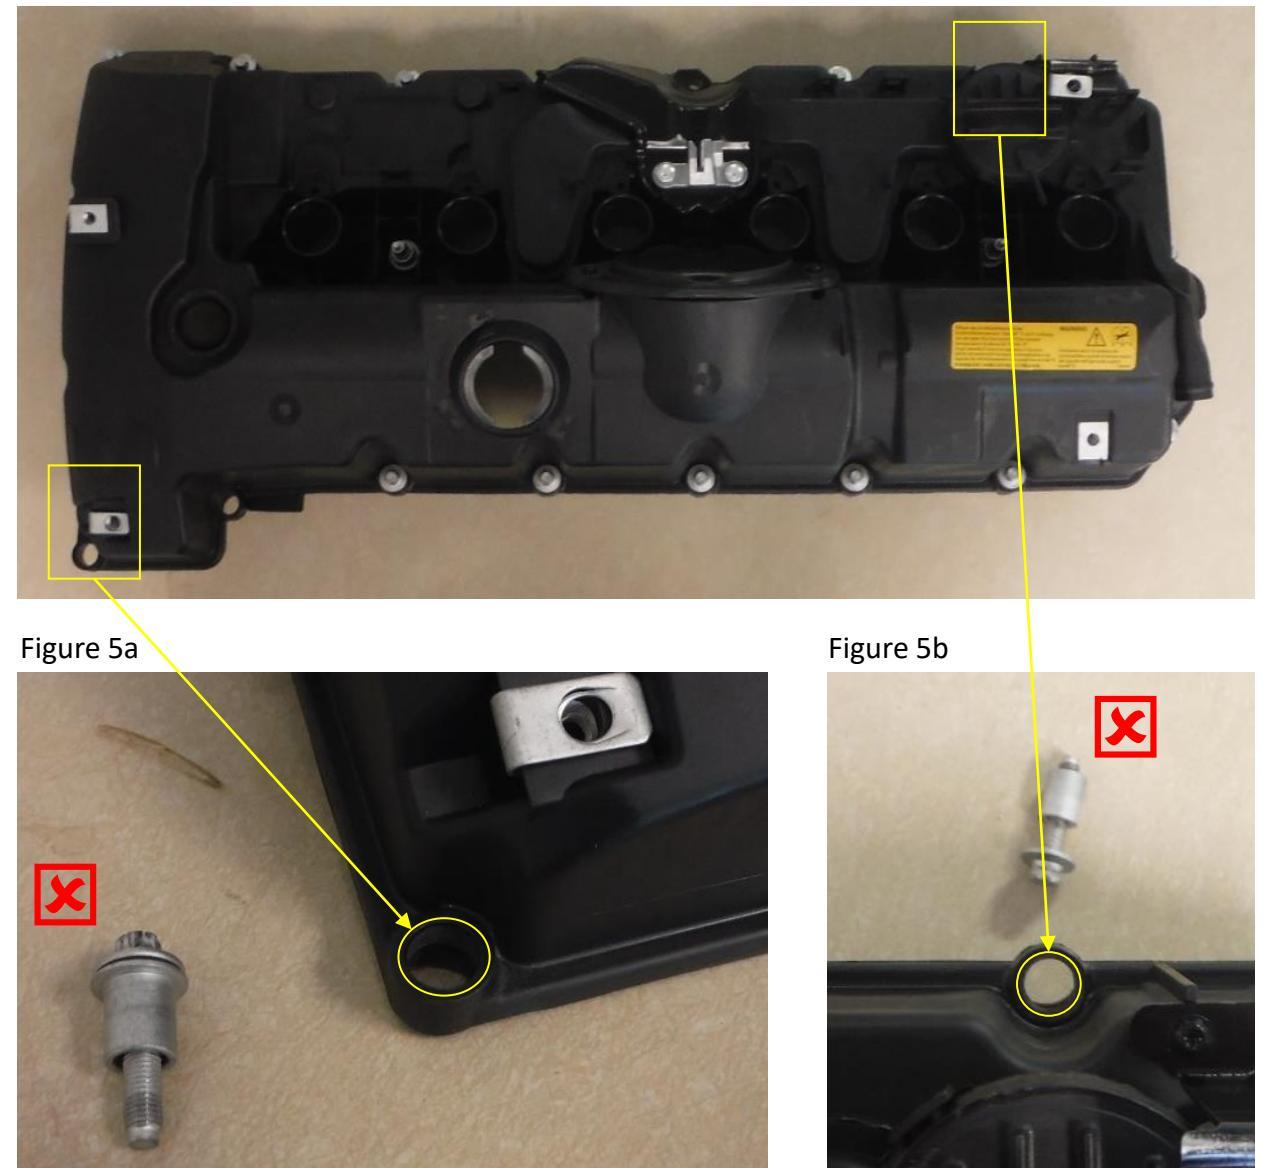
Upon unboxing, the fasteners shown in Figure 5 fell out of the valve cover assembly with little or no outside influence. This is not acceptable for customers. The cover molding must have a proper press-fit/interference fit between the valve cover main body and the fasteners.

Figure 5: Fasteners Falling Out

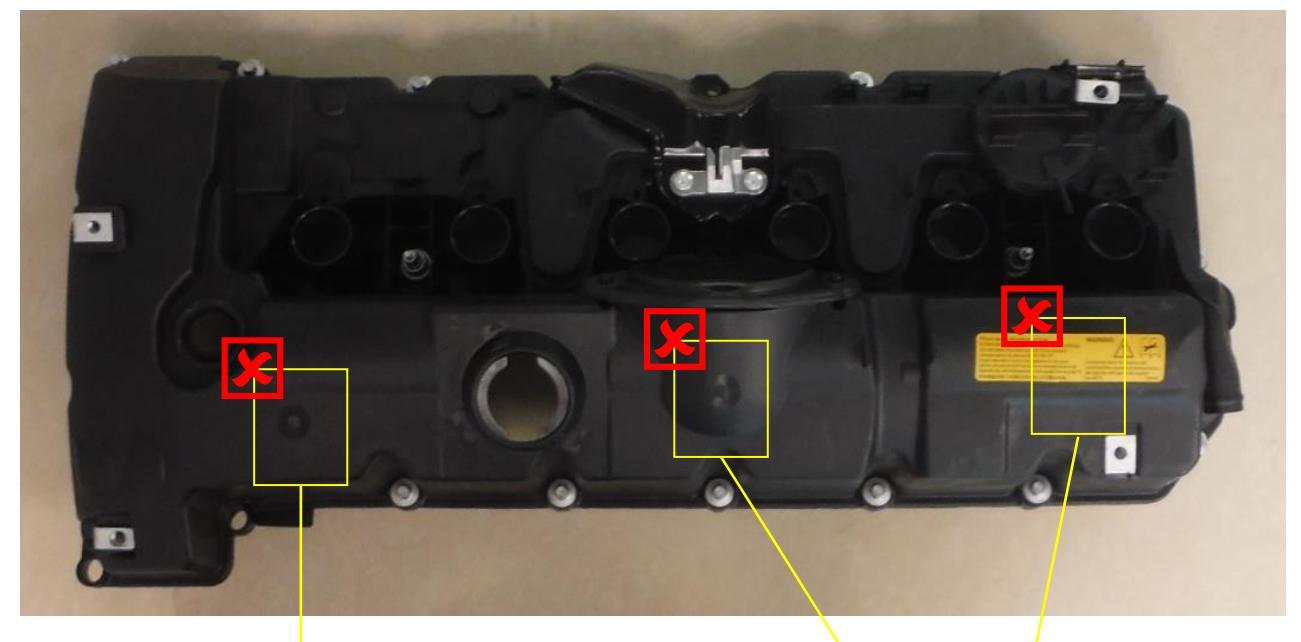
The main molding of the valve cover has rough tooling marks from the injection molding process. These marks are located on the top of the part, where they are visible in the engine bay of the automobile. This is an NG appearance for the customer.

Figure 6: NG Appearance - Tooling Marks

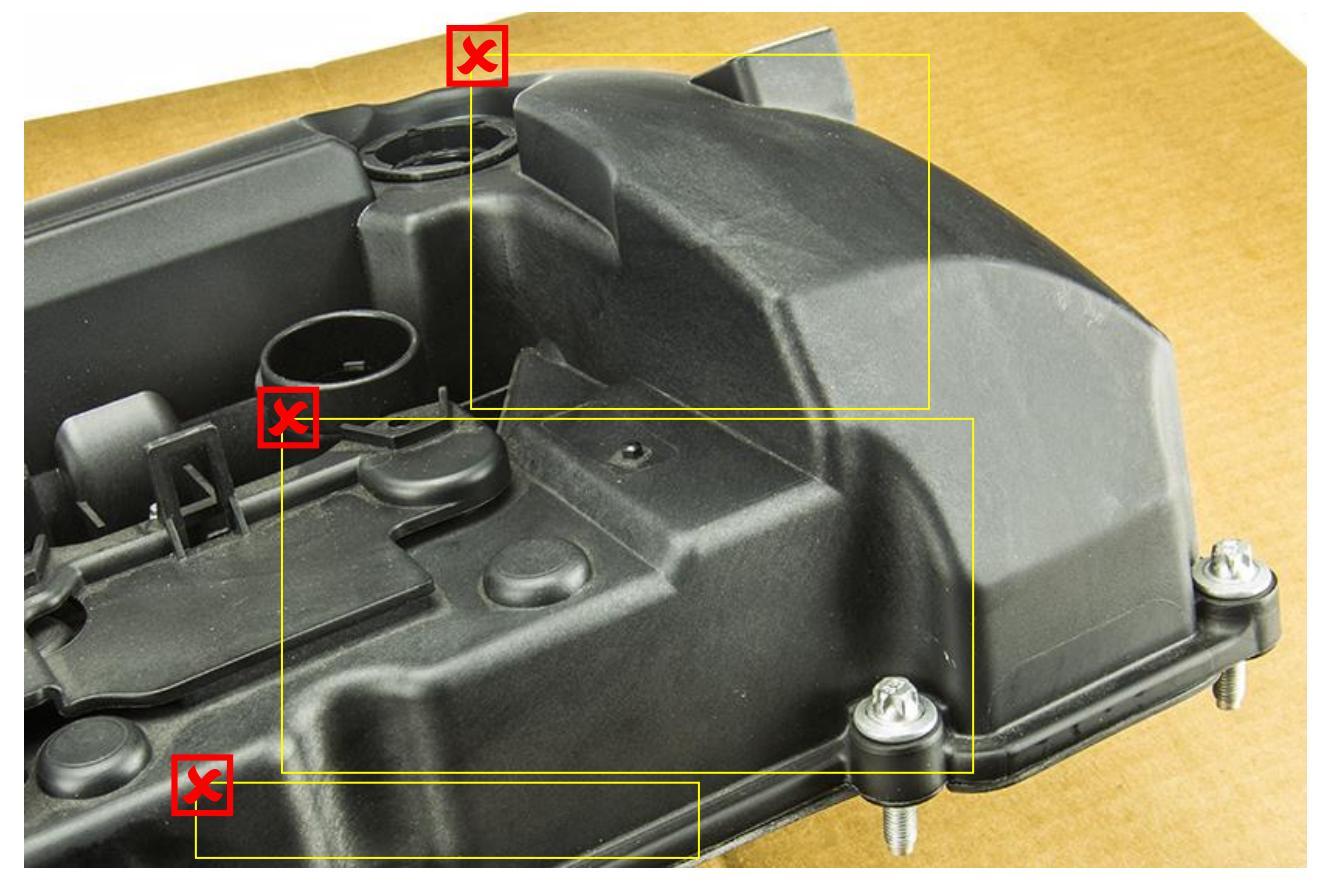
The surface of the OTHER Valve Cover has a mottled, matte grey appearance in areas, which suggests a high percentage of regrind (recycled) plastic. The OEM Valve Cover is an even black color, which is consistent with the use of virgin plastic. (A recycled plastic can never achieve the full mechanical properties of its virgin form.)

Figure 7: NG Appearance – Surface Finish
