Mercedes W215/220 Shift Lever Repair Kit*

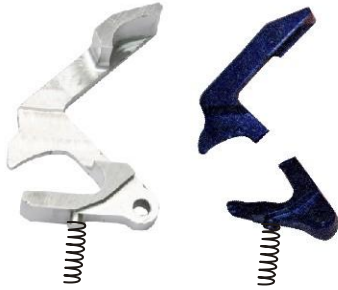
Step 7 – Swap spring from plastic lever to new aluminum lever; may require gentle twisting to remove and install.

*Note: there are 2 styles of shift park levers which are differentiated by the width of the hinge pivot base. Either a 5mm or an 11 mm base may be fitted. This is a running change and not defined by a specific year or chassis. A quick inspection of the existing plastic lever in the shifter may be required before ordering the correct part.
