### **STEP 1 – Review Installation Procedure**

### **STEP 2 – Verify System Voltage**

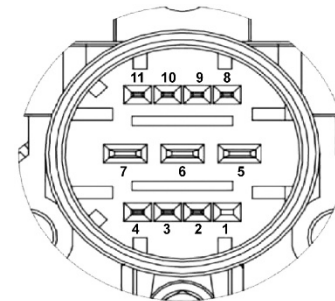
Confirm that the voltages at the actuator connector are normal. Refer to diagram for allowable ranges. If the voltage of any connector pin socket is insufficient or exceeds the specified voltage, the computer board must be tested and repaired.

- **Battery:**  
12.5 - 13.5V
- **Pins 2/3/4/8/9:**  
4.5 - 5V
- **Pin 10:**  
0V
- **Pin 11:**  
+5V
