HEAVY-DUTY ALUMINUM COOLANT BYPASS PIPE

RM0720519PRM | 2014–2019 Jeep, Ram

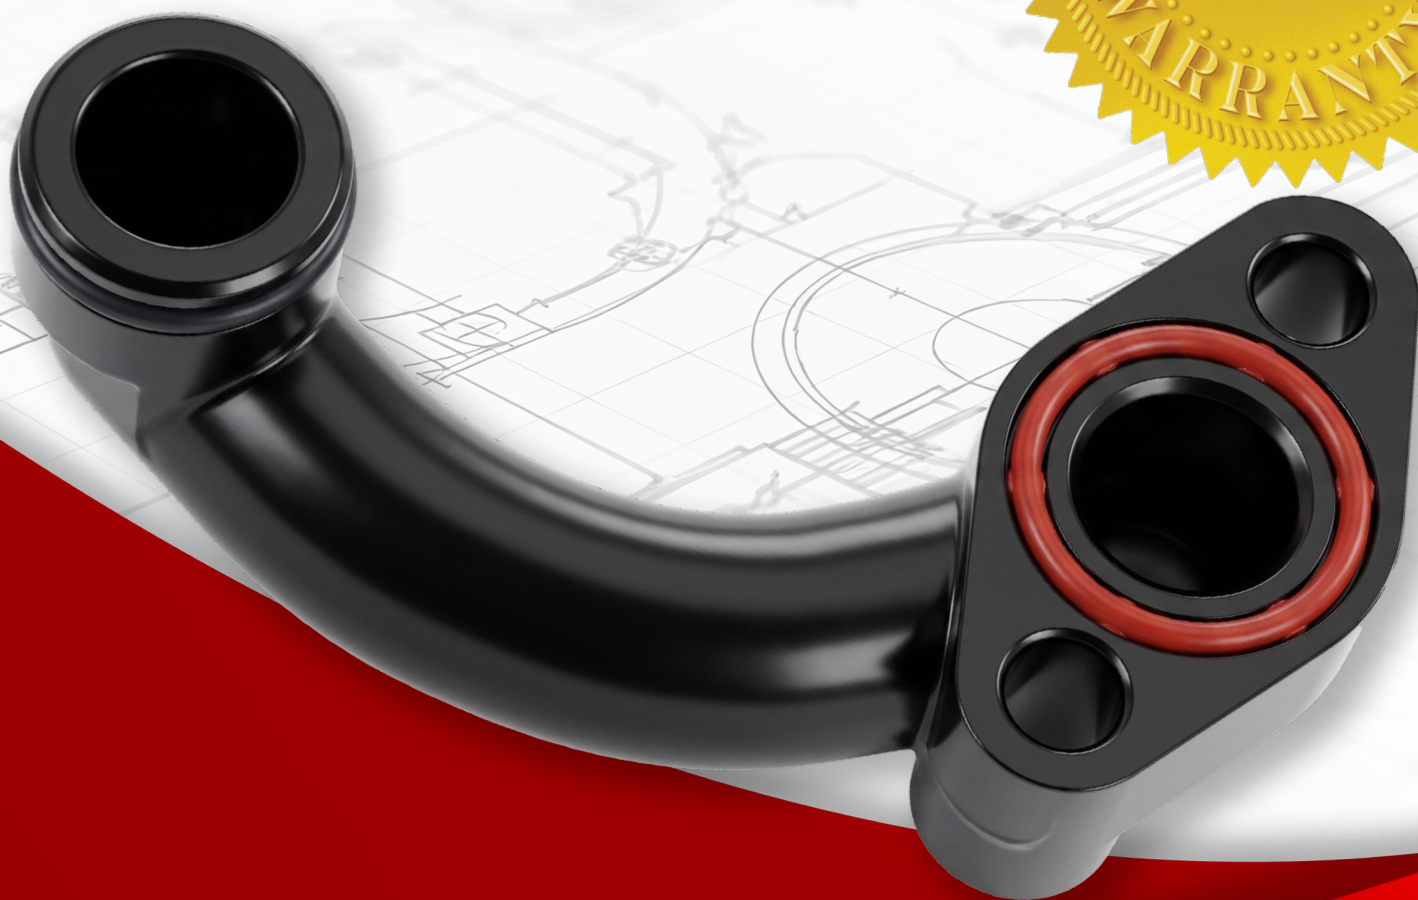
OEM DESIGN FAULT

Plastic coolant pipes are prone to catastrophic failure after repeated thermal cycles and exposure to motor oil, grease, or transmission fluid. The embrittled plastic eventually ruptures, resulting in a major leak and dangerous overheating.

AUTOTECNICA PREMIUM SOLUTION

Autotecnica Premium has developed an aluminum coolant pipe for a truly robust repair, which is impervious to engine heat, motor oil and ATF. The sturdy all-metal replacement fixes the problem right the first time, and is covered by a lifetime warranty.
