VW Trunk Latch Actuator Bracket Repair Kit

Part# 1J5 827 567 A-PRM

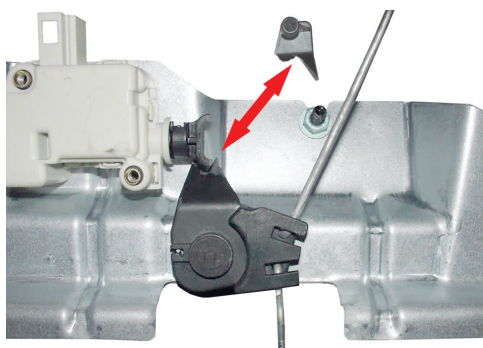
OEM Design

The trunk release actuator found in the VW Jetta MK4 is known for breaking the thin plastic relay lever, which disables the latch release mechanism. Repair typically requires replacement of the entire actuator bracket assembly, which is no more durable than the original failure-prone assembly.

- Actuator usage breaks the plastic relay lever, especially during cold weather
- Replacement of OE bracket assembly is a costly yet temporary repair, and doesn't resolve the fragile relay lever issue

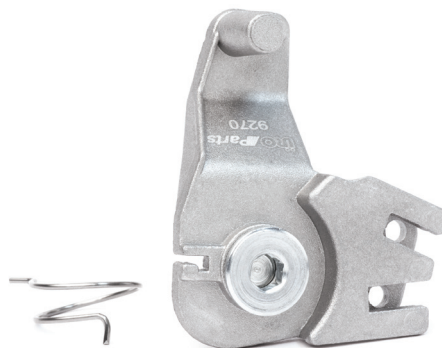
ÜRO Solution

ÜRO Parts redesigned the plastic actuator relay lever using metal for vastly improved reliability. The ÜRO lever is made of sturdy aluminum and reinforced with structural ribs, making the ÜRO lever exponentially stronger than OE. Now you can permanently repair the actuator bracket instead of replacing it!

- Improved design corrects OE deficiencies
- ÜRO relay lever is simple to install
- Aluminum construction is impervious to summer heat and winter cold
- Lifetime warranty
