Mini Cooling Fan Resistor Repair Upgrade

Part# 17 11 7 541 092-PRM

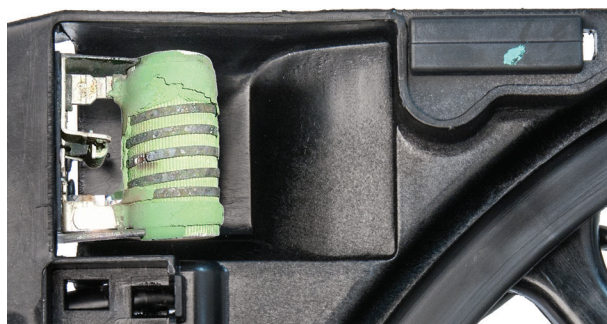
OEM Design

The Mini Cooper suffers from a common failure of the main cooling fan motor speed resistor, which causes the fan to either stop operating or never shut off. Mounted at the front of the radiator inlet grille, the OE design exposes the resistor to harsh weather elements, promoting corrosion and eventual failure. Mini only offers this resistor as part of the costly complete cooling fan assembly.

Problems

- Resistor coil is exposed and unprotected
- Rain, snow, pollutants, blowing sand and flying road debris eventually damage or corrode the resistor winding

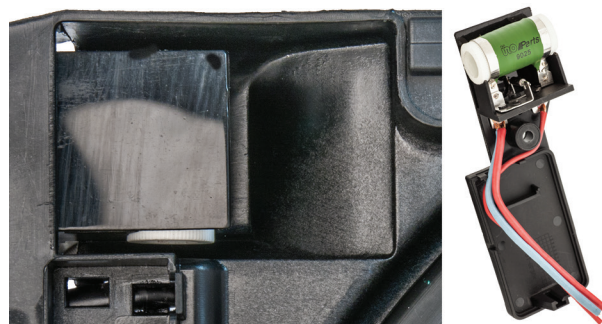
ÜRO Solution

ÜRO Parts developed a repair kit for this cooling fan speed resistor pack that not only saves money by replacing only the failed component, but also provides a more robust repair. The ÜRO Parts Premium Resistor Kit provides a new resistor pack which is similar to the OE design, and adds a durable plastic shield to help protect the resistor coil.

- Protective cover helps shield fragile resistor coil from harsh weather elements, blowing sand, and airborne gravel
- Lifetime warranty
